MERRIMACK RIVER BASIN  
NEW IPSWICH, NEW HAMPSHIRE

SOUHEGAN RIVER WATERSHED  
DAM NO. 13

PHASE I INSPECTION REPORT  
NATIONAL DAM INSPECTION PROGRAM

DECEMBER 1979

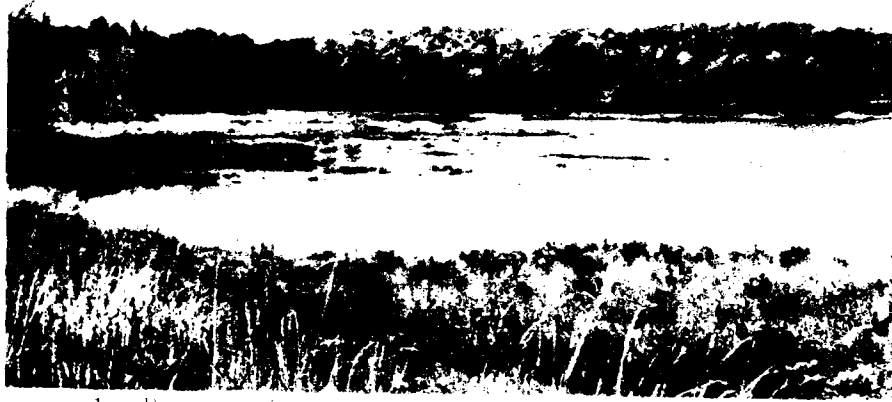
1. Reservoir area from emergency spillway

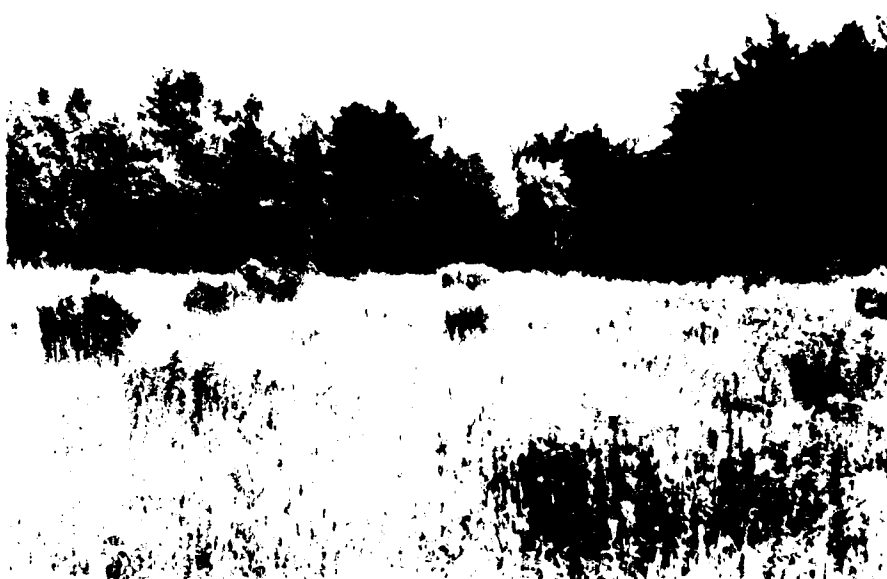
The earth emergency spillway is in good condition. There are wet spots in the channel but these are caused by natural groundwater or ponded runoff.

7. Emergency spillway channel looking downstream

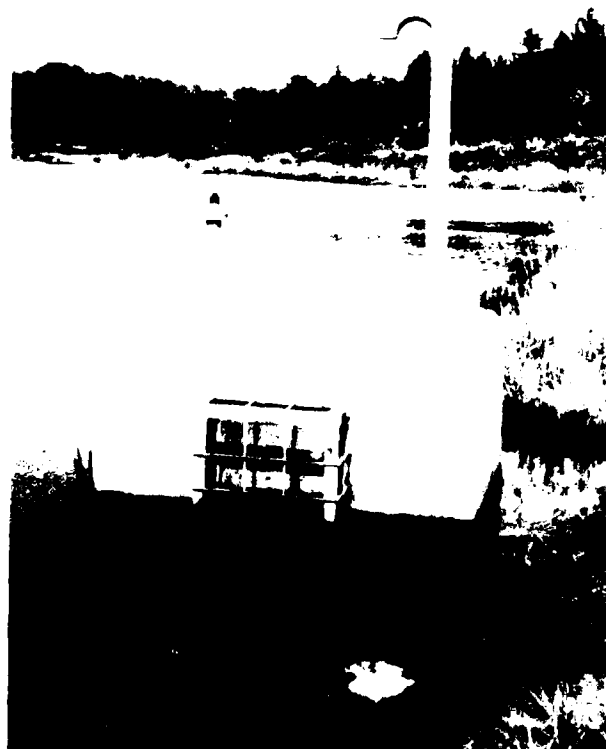
This structure is in GOOD condition, at the present time, with no evidence of cracking or efflorescence. Localized spalling has occurred on the right side of the structure (see Photo 8) covering approximately 4 square inches. This spalling is approximately 1.5 inches deep. The face of the vent pipe pedestal shows localized spalling 1 inch deep over an area 7 inches long by 3.5 inches high. This spalling is attributed to excessive vibration of the concrete during placement. Portions of the trash rack assembly shows signs of severe corrosion (see Photo 3).

8. Drop inlet spillway structure showing spalling of concrete and rusting of trash rack

- (c) Clearing accumulated debris from embankment slopes and trash racks.
  - (d) Backfilling tire ruts, erosion holes and animal burrows with suitable well tamped soil.
- 2) Remove, repair, galvanize, and reset the trash rack assembly.
  - 3) Check the operability of the pond drain gate as part of the annual inspection procedure.
  - 4) Maintain the program of annual technical inspections.
  - 5) Develop a formal written downstream emergency warning system.
  - 6) Repair all spalled and cracked concrete.
